U-Value verification measurement of a Minergie-certified building with greenTEG's gSKIN® U-Value Kit

By: Dr. Lukas Durrer, ETH Zürich, D-MAVT, Micro and Nanosystems Group Tannenstrasse 3, CH-8092 Zurich, Switzerland <u>lukas.durrer@micro.mavt.ethz.ch</u>

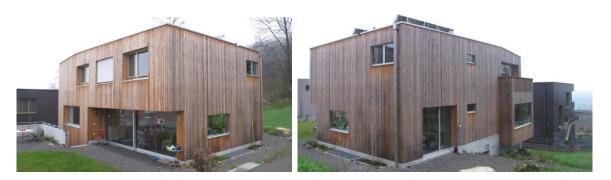
Figure 1: Measurement object is a Minergie-certified standard wood construction in Rickenbach, Switzerland (left hand, south-oriented face; right hand, north-oriented face)

The object of study is a one-family house which was in its final construction phase during the measurement period in October 2013 (Figure 1). The house was completed on the 1st of July 2014 and is Minergie-certified based on an energy calculation by the energy consultancy Otmar Spescha AG (Schwyz, Switzerland).

The building is a wood frame construction. The walls are constructed based on a three-layer plate inside, a Flumroc insulation layer (WD Flumroc Solo) and a DHF wall for the exterior. Wooden struts contribute to the stability of the walls.

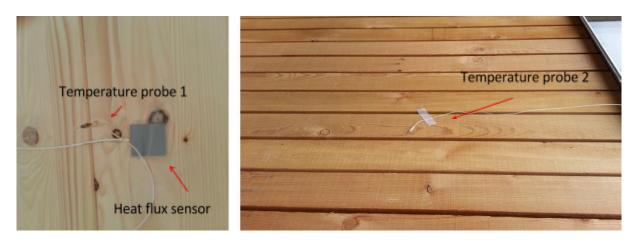
Figure 3: Mounting of heat flux sensor and temperature probe 1 (inside) and temperature probe 2 (outside)

The U-Value was measured for a north facing wall. The heat flux sensor was mounted in the middle of the inside wall using regular adhesive tape. One of the two temperature probes was mounted in close proximity to the heat flux sensor. The second temperature probe was mounted on the outside wall in roughly the same position as the heat flux sensor (Figure 3).
